6 seconds Implosion Was Years in the Making

It took less than six seconds for hundreds of synchronized blasts to flatten the old Bay Bridge's largest concrete pier. But it took years of preparation and collaboration with permitting agencies to ensure the implosion went smoothly, safely and with minimal impact to wildlife and the sensitive environment of San Francisco Bay.

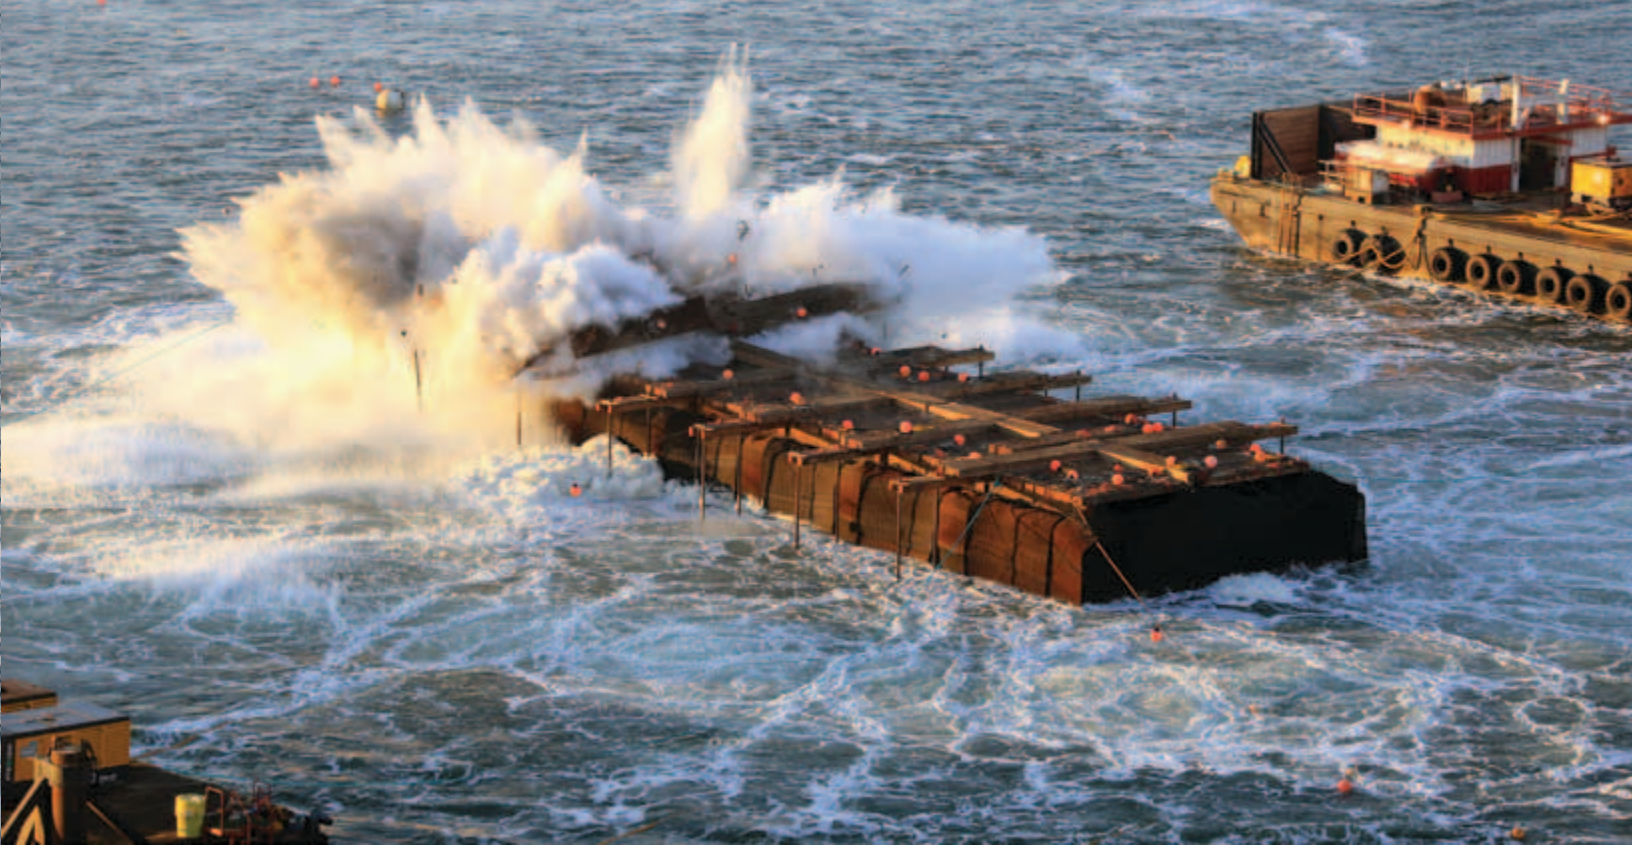
Early in the morning on Nov. 14, nearly [600 controlled charges](#) weakened the 50 feet of Pier E3 which stood from the bay floor to the waterline, allowing gravity to collapse the tower into its hollow casing below the mudline.
